**HYDROGEN PEROXIDE ACCIDENTS AND INCIDENTS:
WHAT WE CAN LEARN FROM HISTORY ***

Ben Greene
Honeywell Technology Solutions, Inc.
NASA Johnson Space Center White Sands Test Facility
Las Cruces, New Mexico

ABSTRACT

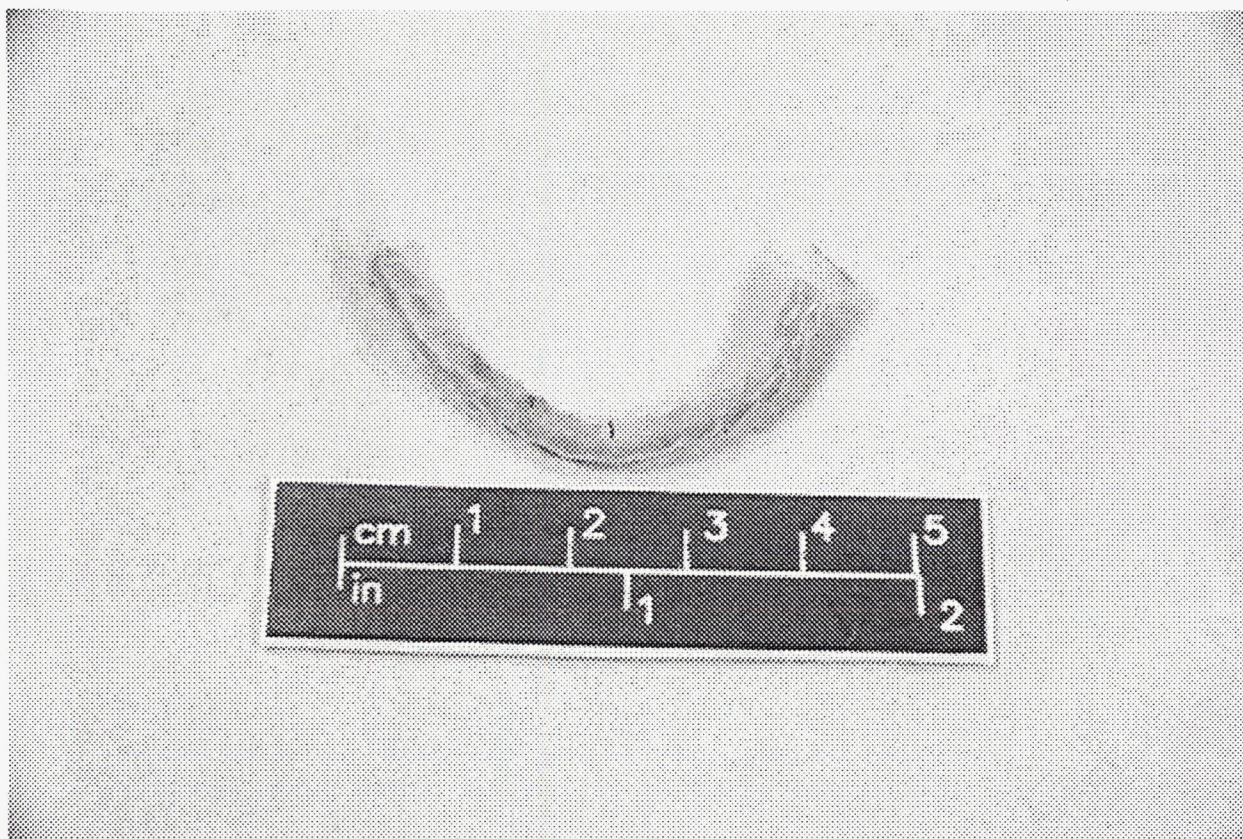
The test specimen was a mild carbon steel, approximately 6-cm long with a 0.25-cm outer diameter, and was shrink-wrapped in fluorinated ethylene propylene (Teflon® FEP). The Teflon® FEP sheath exposed portions of the carbon steel surface and is shown in Figure 1. A 150-mL beaker was charged with 50 mL of 98 percent hydrogen peroxide (FMC), and a sheathed thermocouple was immersed in the fluid until the temperature equilibrated. The test specimen was then immersed in the fluid and the reaction and temperature were monitored periodically for 24 h.

Figure 1. Carbon Steel Shrink-Wrapped Test Specimen

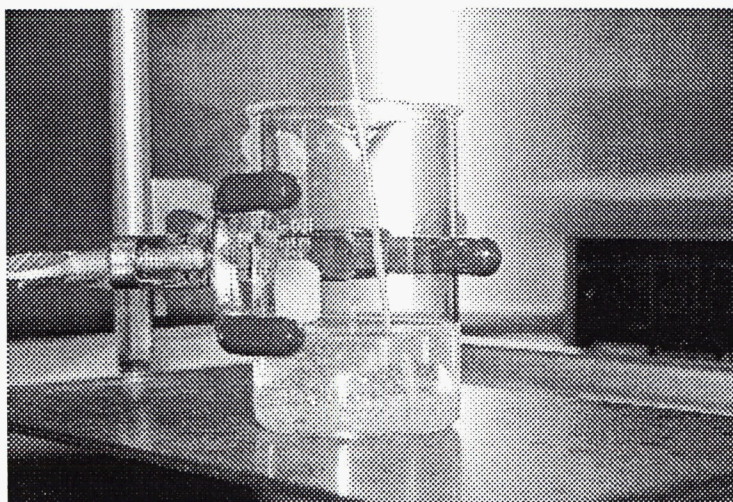
The failure of a Class 1 protective liner in contact with a Class 4 metal has been reported elsewhere.¹ Our experimental results from the simulated failed liner test showed that hydrogen peroxide in contact with a carbon-steel gradually decomposed. Figure 2 is a photograph of the reaction mixture after the 24-h period. Although oxygen was evolved, there was no significant temperature rise over the 24-h period because the reaction was mild and gradual in the open beaker in the constant air stream of the fume hood. Had this occurred in a storage vessel or in a system without adequate pressure relief, severe consequences as a result of accelerated hydrogen peroxide decomposition, such as expulsion of liquid through a vent or an explosion, could have occurred.

Figure 2. Reaction Mixture after 24-h Period

Our experiment illustrates this possibility. These above examples further demonstrate the need to understand the history of the development of safe packagings for hydrogen peroxide.

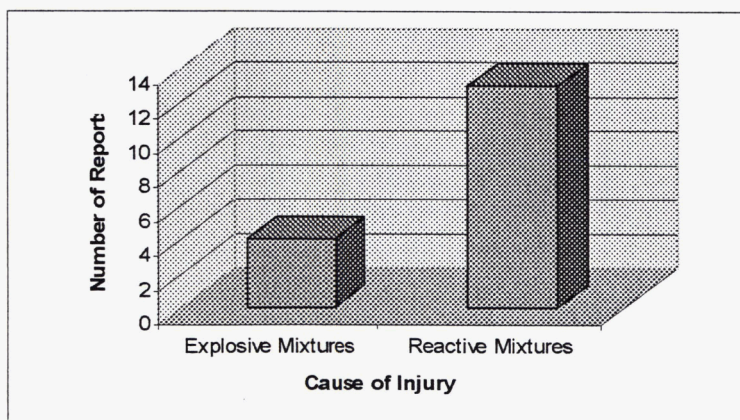
We found two major causes of injuries: reactive mixtures and explosive mixtures, as illustrated in Figure 3.

Figure 3. Major Cause of Injuries

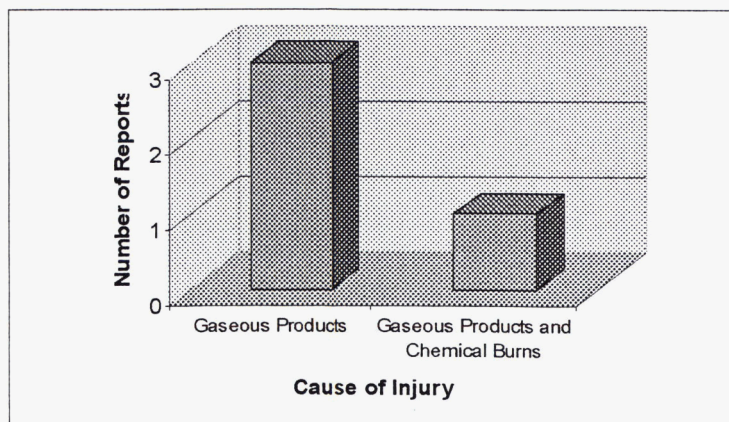
There were four accident reports in which the cause was a reactive mixture of hydrogen peroxide and other materials. Of these four reports, there were three causes of injury by exposure to gaseous products and one cause of injury due to both exposure to gaseous products and chemical burns. This is illustrated in Figure 4.

Figure 4. Effects of Reactive Mixtures

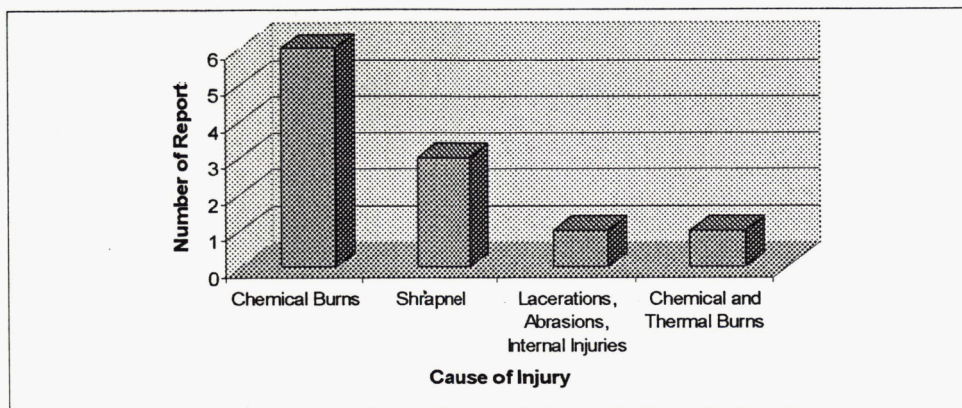
There were 13 accident reports in which the cause was an explosive mixture of hydrogen peroxide and other materials or in systems. Of these 13 reports, there were six causes of injury due to chemical burns, three causes of injury due to shrapnel, one cause of injury due to lacerations, abrasions, and internal injuries, and one cause of injury due to chemical and thermal burns. This is illustrated in Figure 5. There were two fatalities in which the causes were explosive mixtures; these fell in the cause of injury category due to shrapnel and were discussed earlier.^{20, 24}

Figure 5. Effects of Explosive Mixtures
